**Coal Combustion Waste Impoundment  
Dam Assessment Report**

*Site 7  
1982 Pond & 1964 Pond  
Progress Energy Carolinas  
Asheville, North Carolina*

**Project # 0-381  
Assessment of Dam Safety  
Coal Combustion Surface Impoundments  
For the REAC Program**

**June 2009**

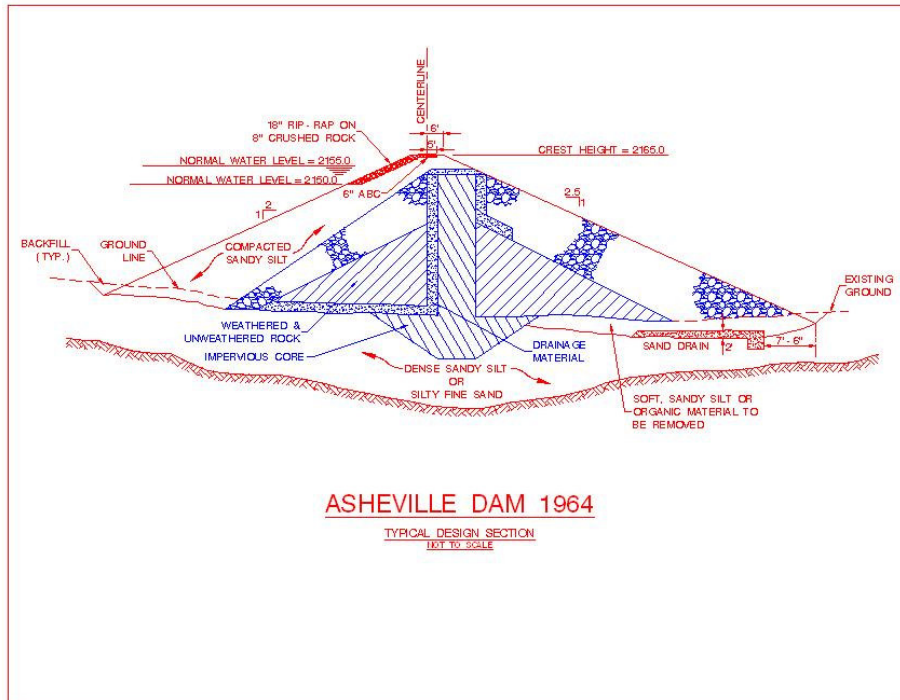
1964 Dam – The dam embankment is a composite of compacted random earth fill and rock fill with a vertical impervious core and chimney drain system to control seepage. The following figure of the 1964 Dam Typical Design Section is representative of the configuration of the management unit.

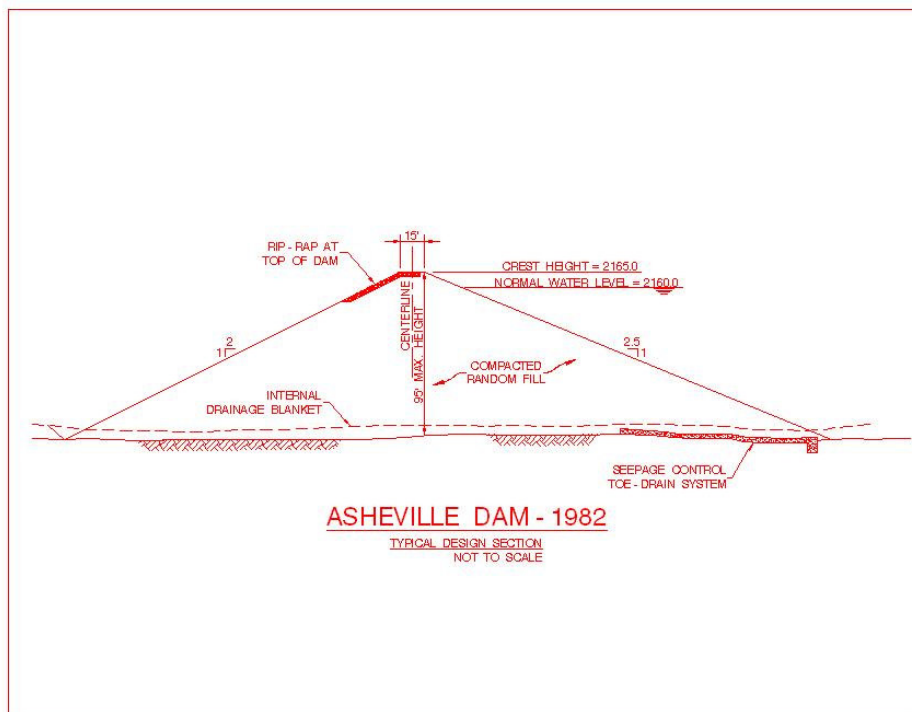
1982 Dam – The dam embankment consists of compacted random earth fill with an internal drainage blanket and toe-drain system to control seepage. The following figure of the 1982 Dam Typical Design Section is representative of the configuration of the management unit.

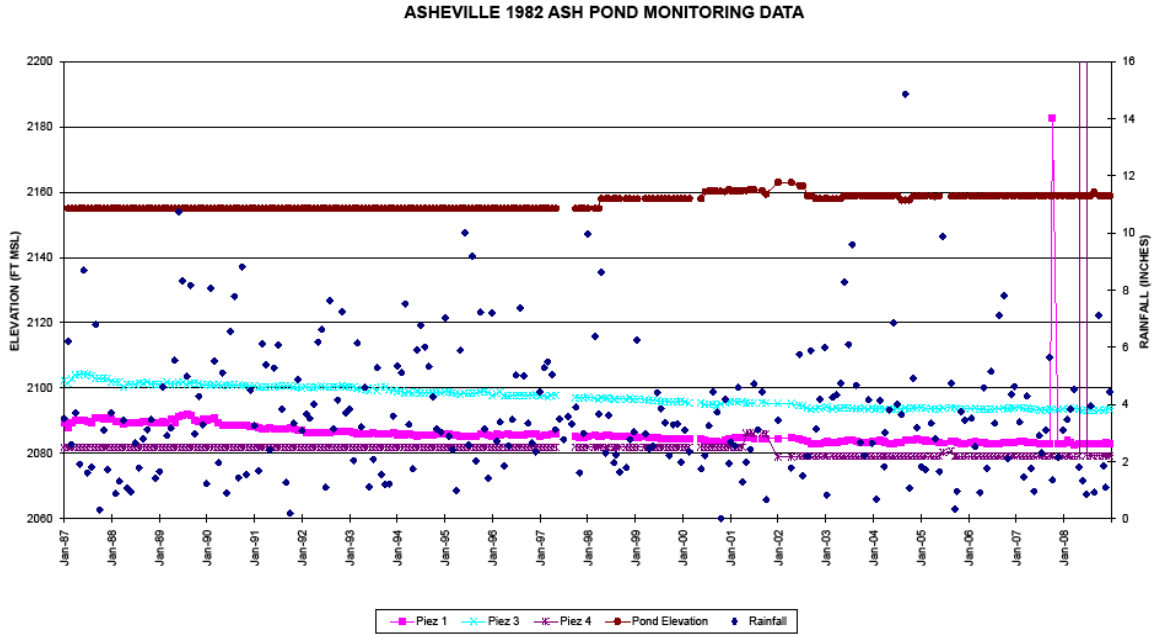
Appendix A – Doc 16: Page 10. The following chart represents piezometer readings recorded from January 1987 to May 2009 and indicate a steady and consistent trend.

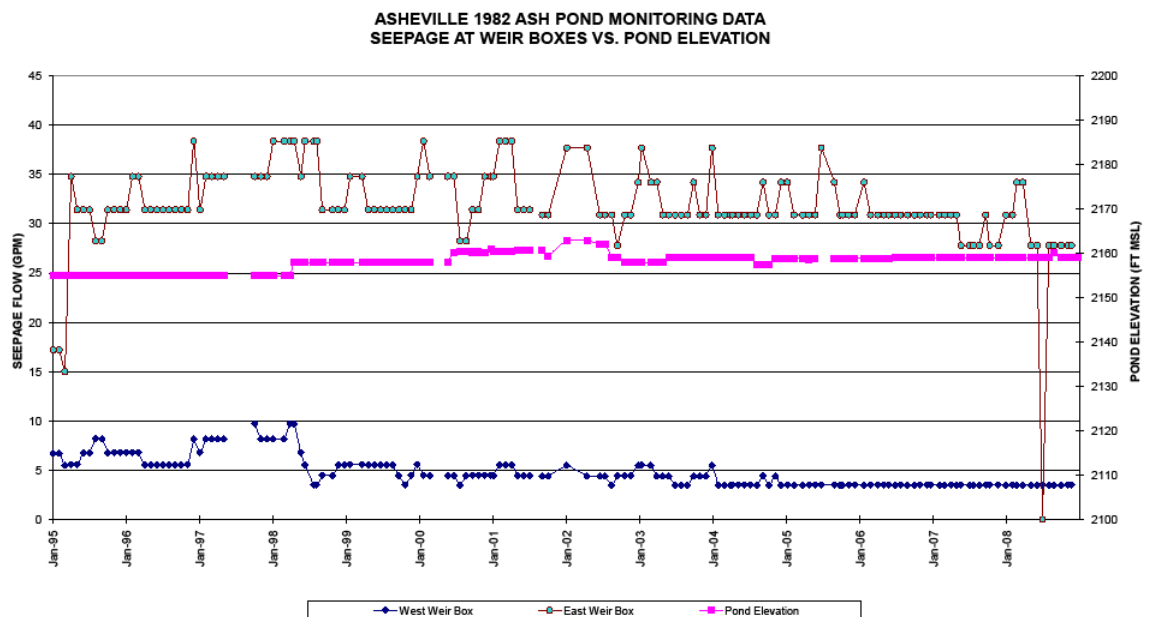
1982 Dam - Data is recorded on a standard inspection report for Progress Energy Carolinas. A copy is given to Richard Horton, with PEC's PGC – Field Engineering Department, and one additional copy is maintained in Progress Energy's files. Please refer to Appendix A, for sample reports. The following chart represents seepage readings recorded from January 1995 to May 2009, for the east and west outlets of the internal drainage system, and indicate a consistent trend.
